Reachable Appraisals & Home Inspections

Home Inspection
95 Wesleyan Way
Oxford, GA 30054

146 Garrison Court
Temple Ga 30179

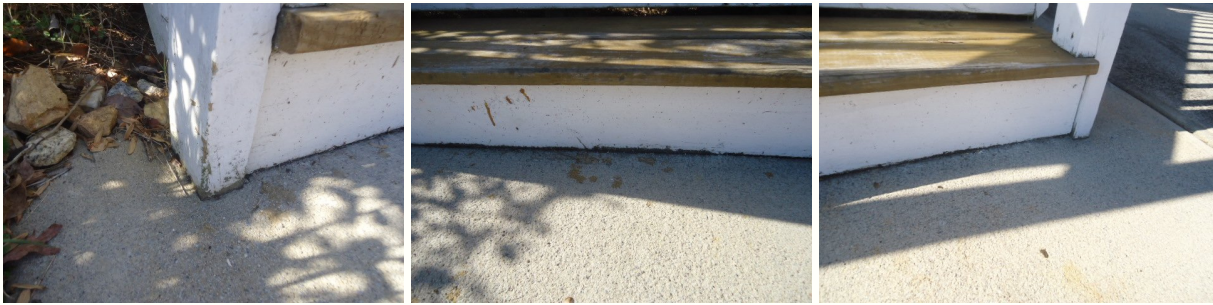
There is chipped paint at the bottom step and the bottom of the stairs railing post. This is because of water damage. It is also recommended to have wooden steps painted to help prevent water damage. I would recommend seeing a general contractor for further details.

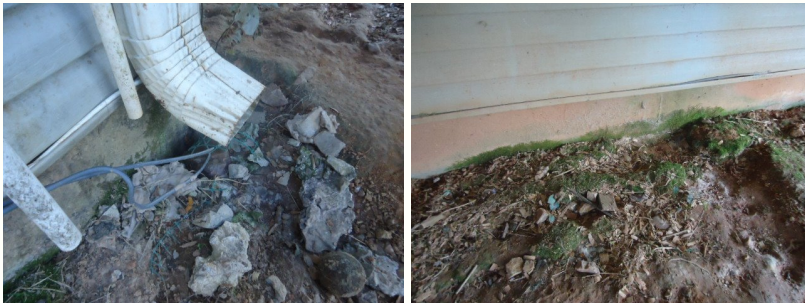
- There are low areas where water could pool.

Under the back deck, there is water damage to the foundation from improper drainage. The grading around the house should drop 1 inch for every 1 foot sloping away from the house. This would help prevent water from pooling up around the foundation. I would recommend seeing a landscaper for further details and repair.

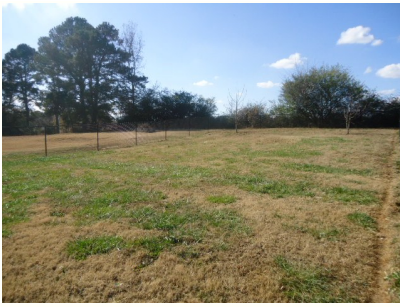
- The ground slopes toward the house.
- There are low areas where water could pool.

The back yard slopes towards the house. This allows for water to flow towards the house. It is recommended that a sufficient swale be placed. I would recommend seeing a landscaper for further details and repair.

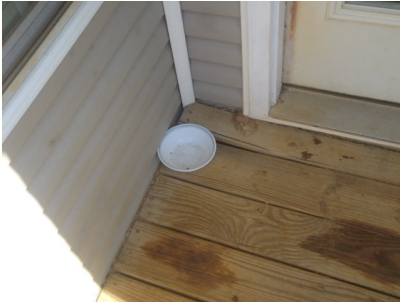
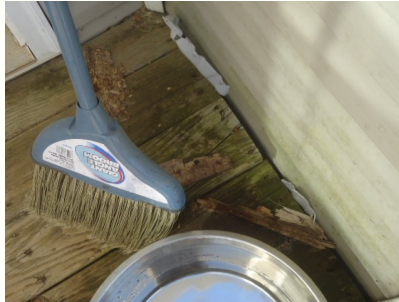
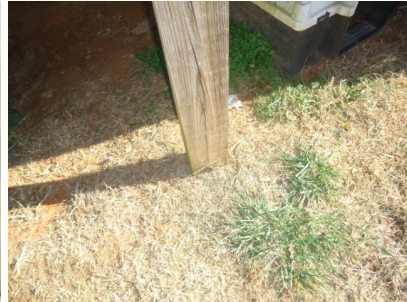
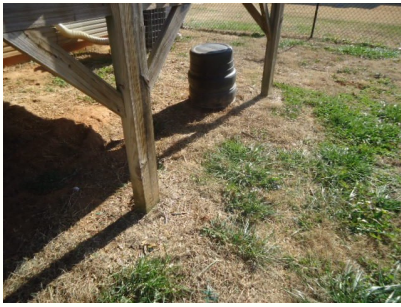
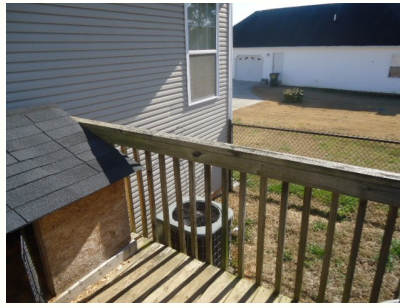
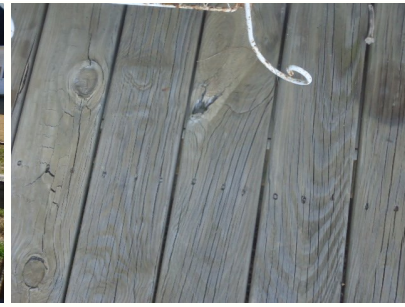
·There are signs of cracking/deterioration on the floor/railings.

It is recommended that all dirt be dug out around the deck posts to show concrete footings. The railing on the opposite side of the back deck stairs is loose. Some of the wood flooring is warped and some of the wood flooring is also cracking/deteriorating from weather. The front porch has cracks and water stains. I would recommend seeing a general contractor for further details and repair.

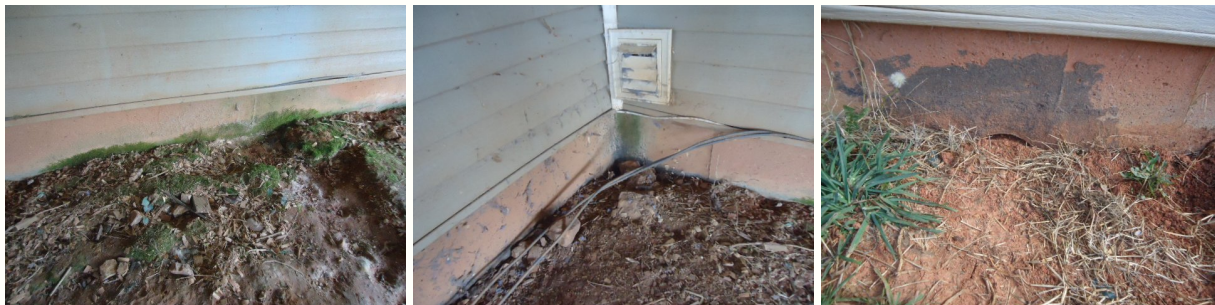
- There are signs of water penetration / condensation to the foundation.
- There are gaps in the mortar.

Around and under the back porch, there is moss is growing on and near the foundation. Moss retains moisture and can eventually cause moisture damage to the foundation. This is from improper drainage, as water runs towards the foundation and pools up, allowing for moss to grow. There is also a hole in the foundation between the ground and the foundation on the back right side of the house by the heat pump. This allows for water entry and pest entry. Please see a general contractor for further details and repair.

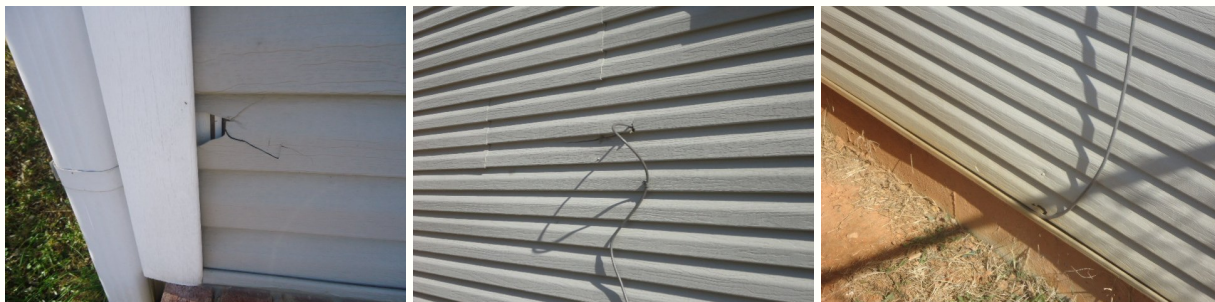
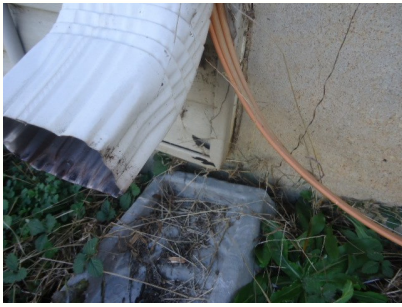
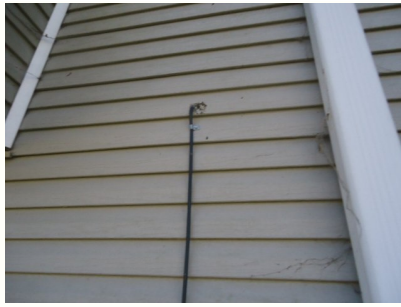
- Cracks, holes, or deflections were observed in siding.

There are some holes/cracks in the siding in a couple of different spots. This allows for easy water/pest entry. It's recommended that a general contractor is seen for further details and repair.

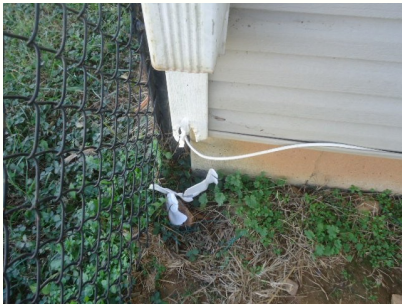
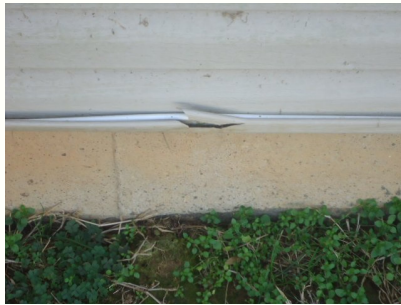
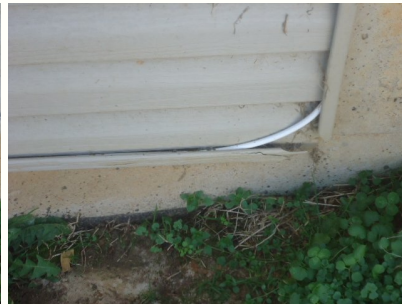
Some of the trim has holes/deflections in it. It's recommended to see a general contractor for further details and repair.

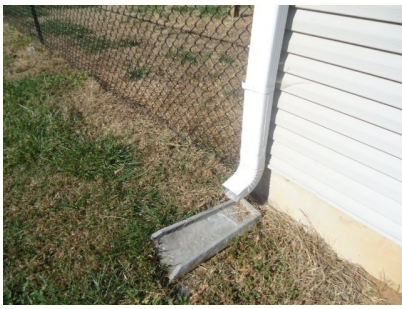
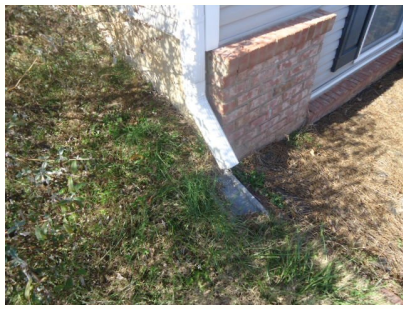
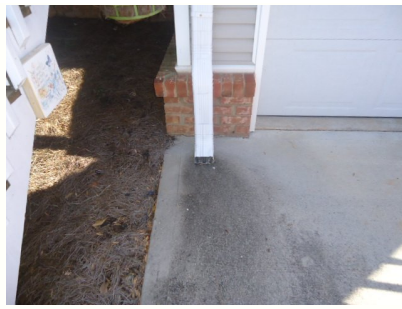
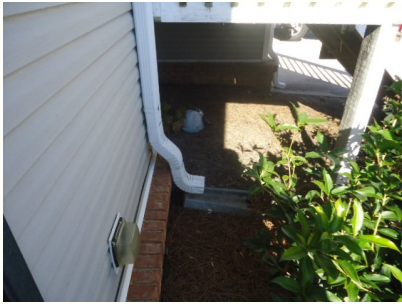
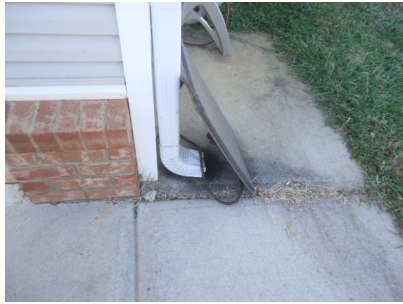
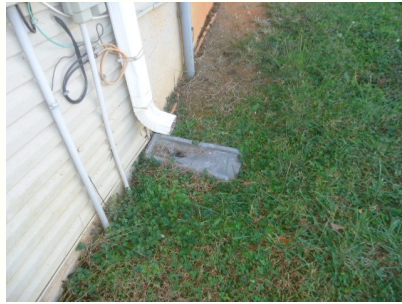
Downspout extenders should be added to all downspouts to prevent water from pooling around the foundation. It's recommended to keep downspouts extended 5' - 6' from the building.

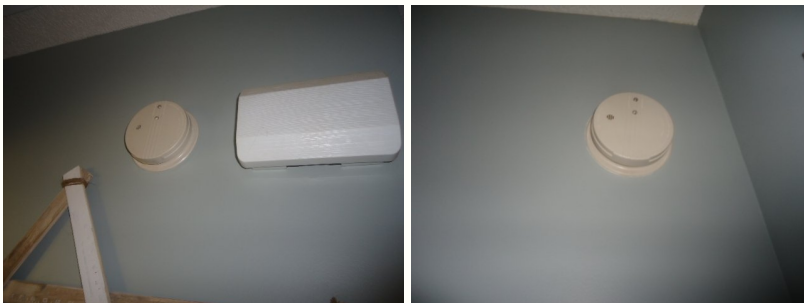
The smoke alarms need new batteries. It's recommended to keep the batteries changed every 6 months.

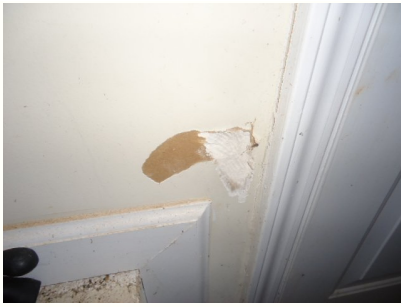
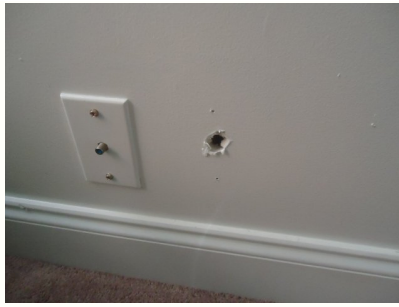
·There are cracks or holes in the walls.

In the bedroom to the right of hall bath, there is a hole in the wall on the far side wall. There are also deflections in the wall behind the handrail endings leading to the basement. There's also another deflection by the door leading outside to the garage. It's recommended to see a general contractor for further details.

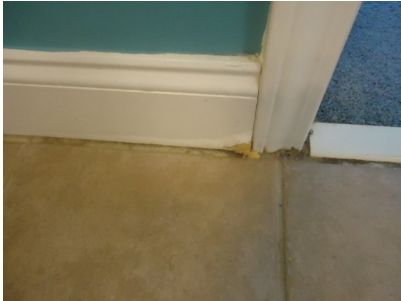
There is water damage to a baseboard right beside the door frame. It's recommended to see a general contractor on further details and repair.

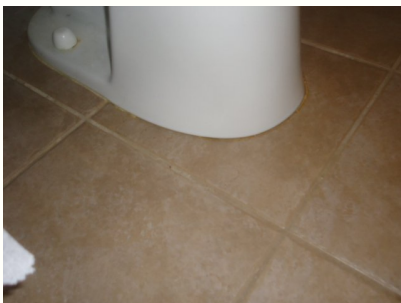
The toilet in the master bathroom should be recaulked to the floor. It's recommended to see a licensed plumber for further details and repair.

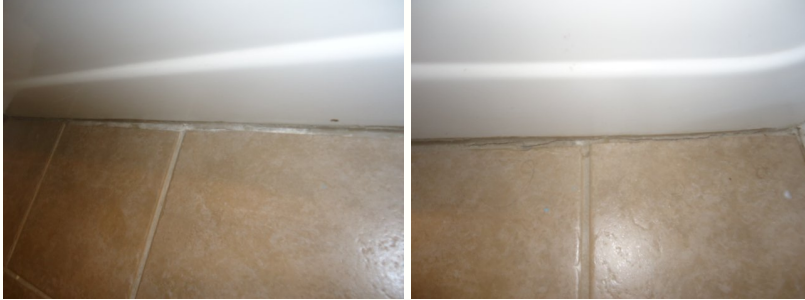
There are cracks all along the base of the tub and the floor. The master tub should be recaulked to the floor. It's recommended to see a licensed plumber for further details and repair.

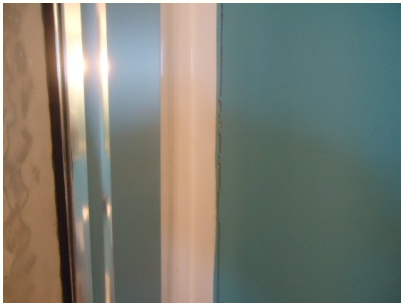
There is cracking between the wall and the shower walls. The shower should be recaulked to the wall. It's recommended to see a licensed plumber for further details and repair.

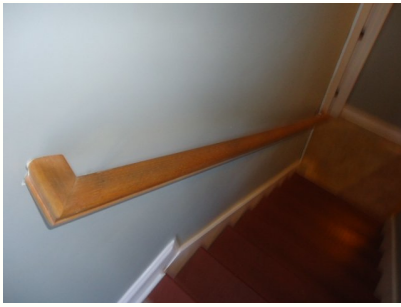
The handrail leading to the basement is loose. This is a safety hazard. It's recommended to consult with a general contractor for further details and repair.

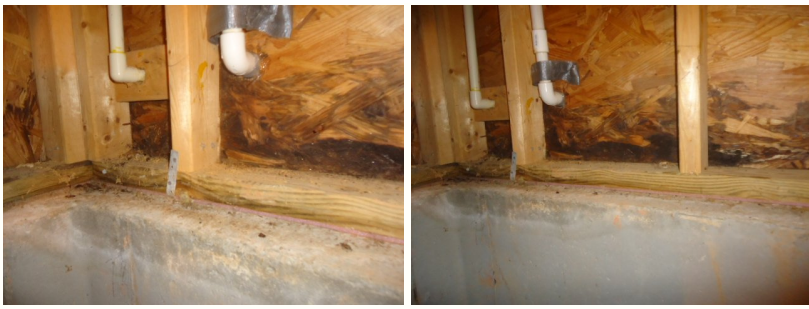
There is a spot in the utility closet on the plywood framing of the house that looks like there may have been a past leak of some kind. There's a pipe that has duct tape on it. The plywood also has some black spots on it that looks like possible mold. I would recommend seeing a licensed plumber to make sure this pipe is no longer leaking, and a mold inspector to make sure that the black spots aren't mold.
