Reachable Appraisals & Home Inspections

Home Inspection
95 Wesleyan Way
Oxford, GA 30054

146 Garrison Court
Temple Ga 30179

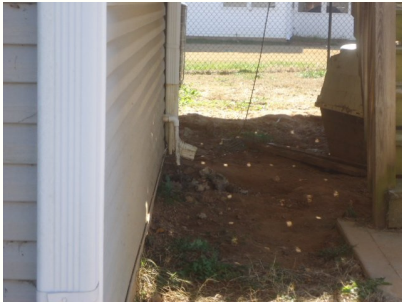
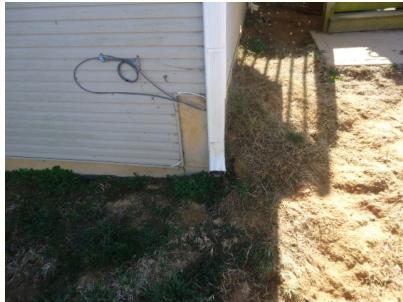
Downspout extenders should be added to all downspouts to prevent water from pooling around the foundation. It's recommended to keep downspouts extended 5' - 6' from the building.
